Chiller Installation Common Mistake

Air Handling Unit Installation Common Mistake

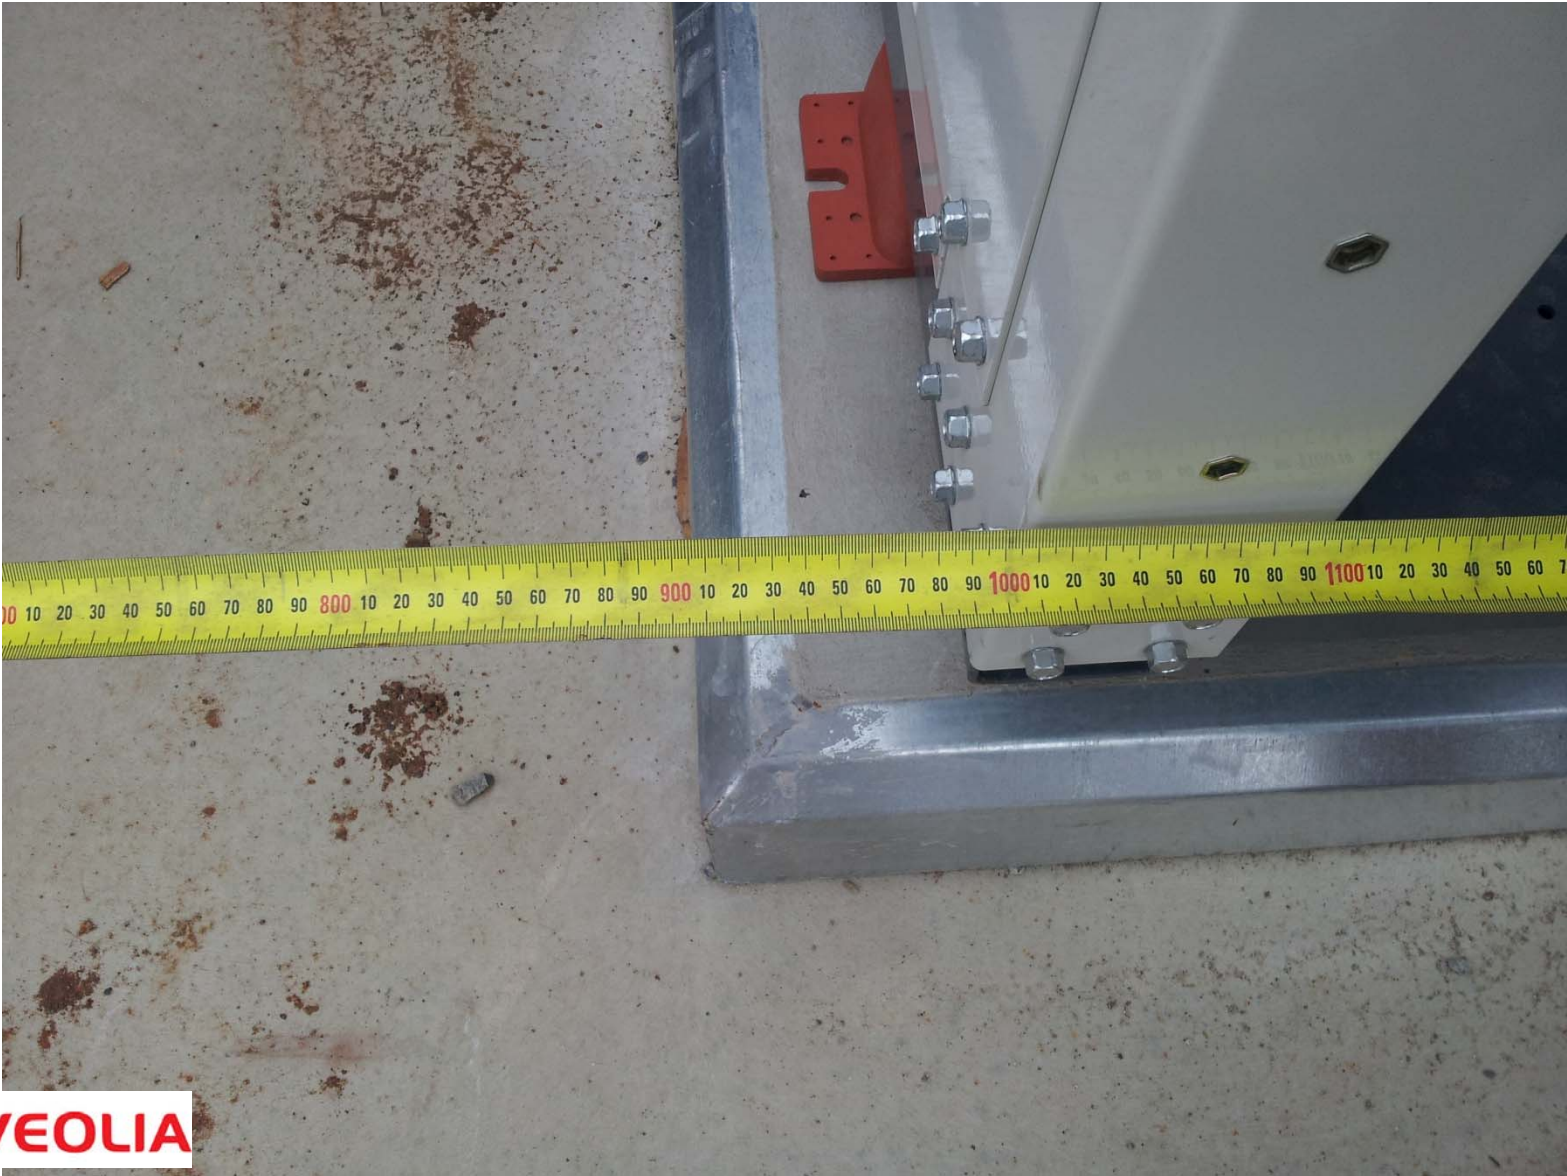
Chiller Installation – Close Spacing

Chiller Installation – Close Spacing

- Two or more chillers located side by side less than manufacturer's recommendation

- Check with manufacturer for spacing requirement
- If plant room size is limited, check with manufacturer for recommendation

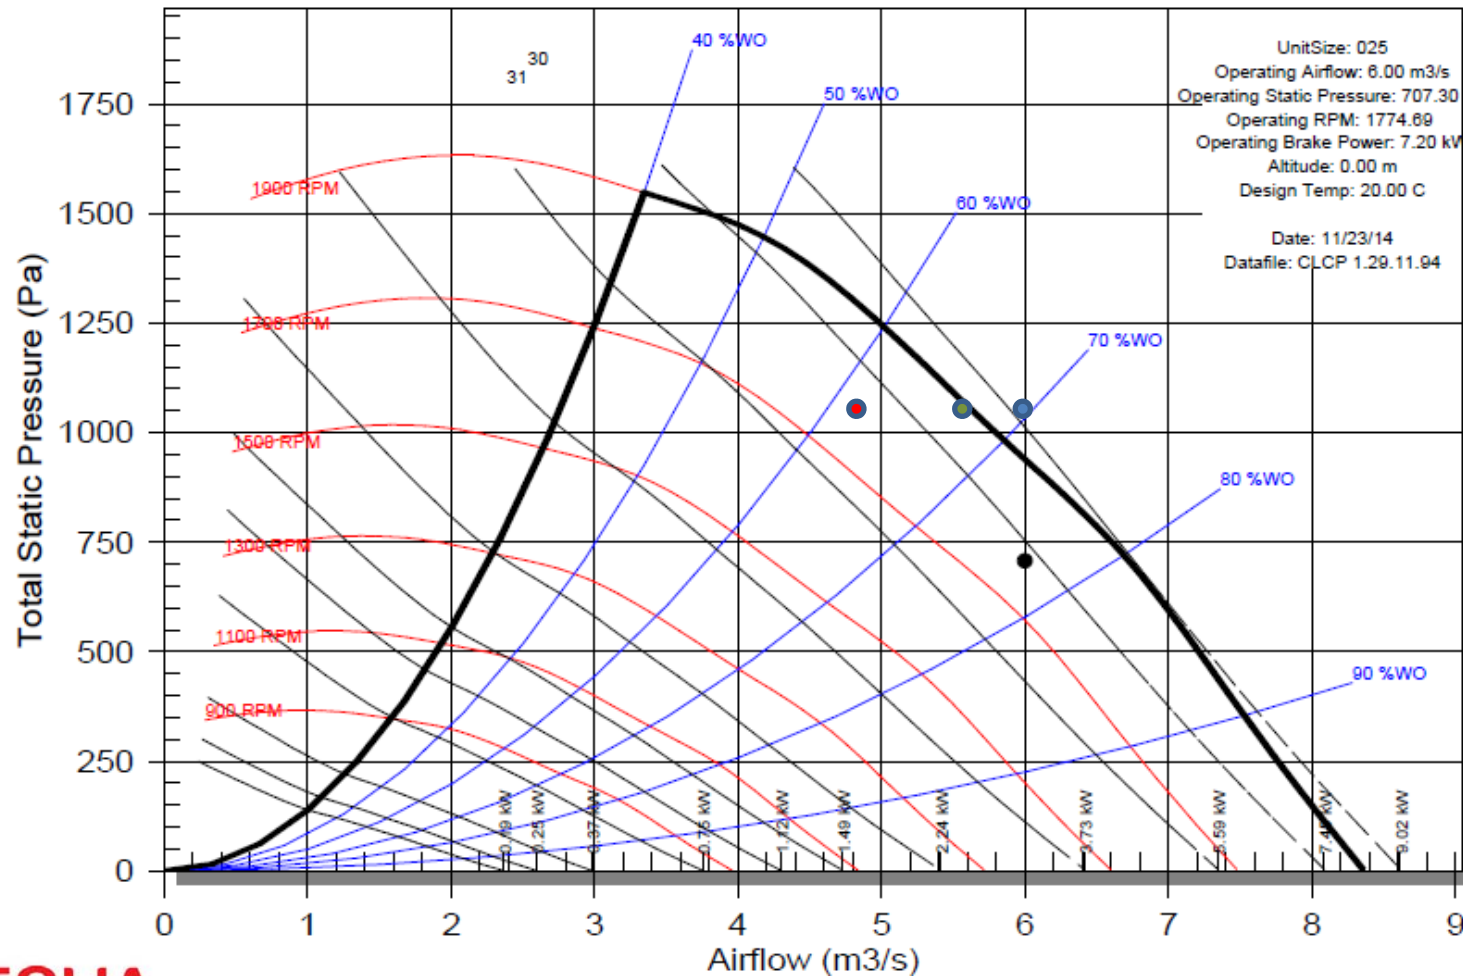
CLCP-2 - Supply Fan Mod [2]-1
AF 500C
