# Retrofits reveal asbestos dangers

Many commercial buildings built prior to 1990 are now being retrofitted to deliver energy savings and improve indoor environments. While this presents great opportunities for our industry, a life-threatening danger exists for all HVAC&R contractors working in such buildings, as Sean McGowan warns.

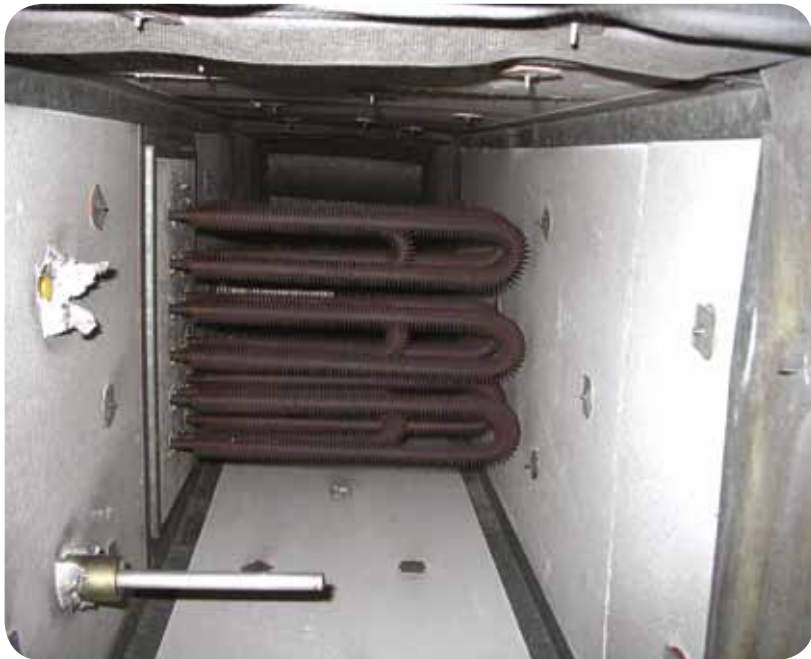
*Asbestos lining within a heater bank.*

For instance, asbestos sheeting (more widely known as millboard) was commonly used to insulate heater banks within ducted systems. Similarly, it was also used within the switchboards of mechanical plant. In fact, anywhere where asbestos-free millboard is found now, asbestos sheeting was likely its predecessor.

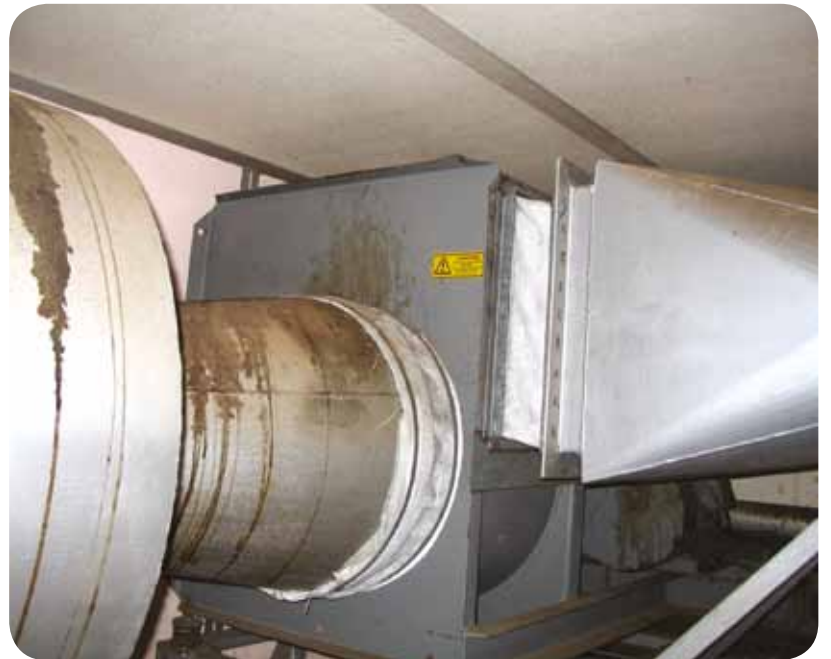
*Textile flexible joint in the exhaust duct.*

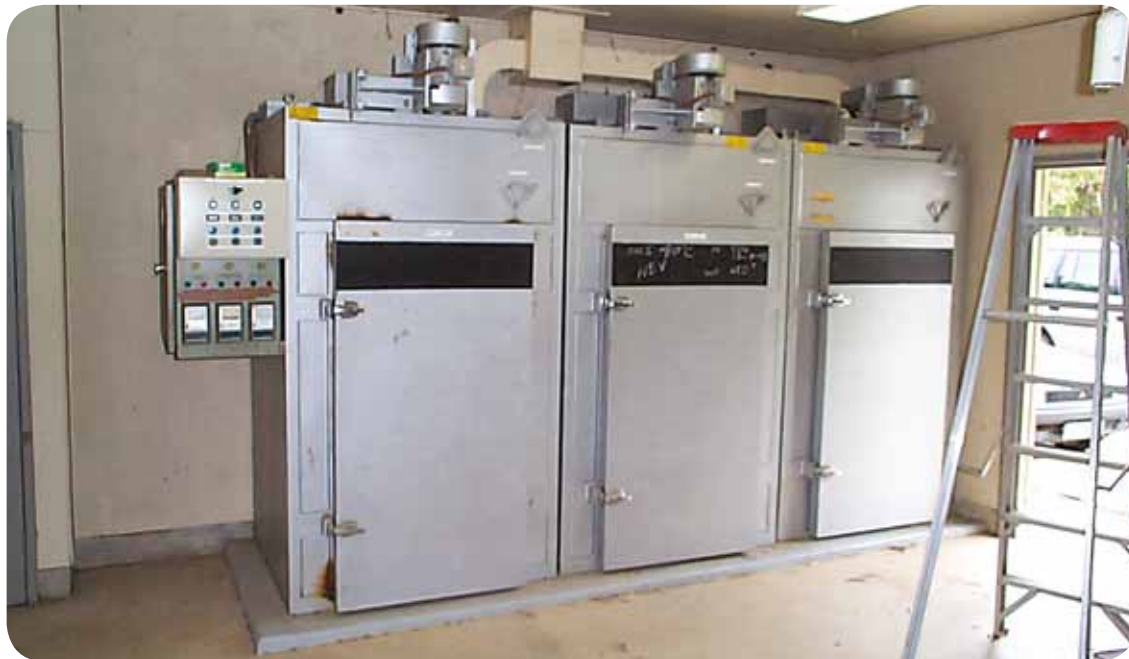
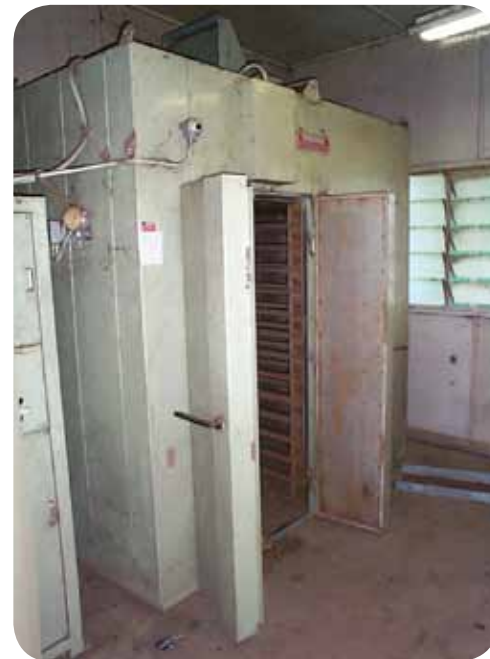
*Drying cabinets containing heater banks with asbestos lining and textile wrapped electrical wiring.*

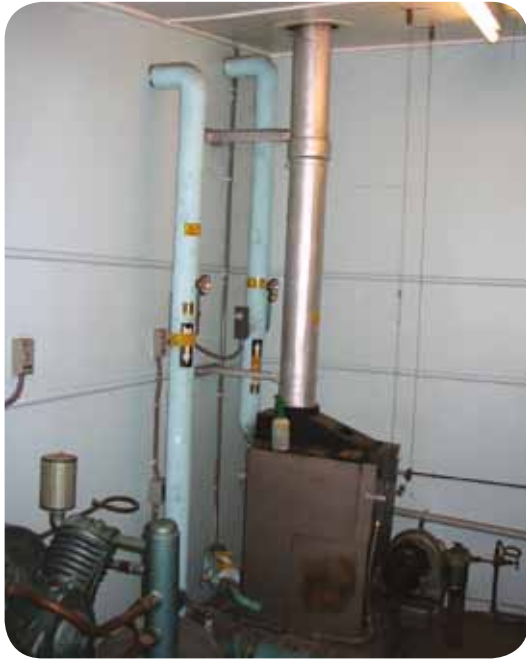
*Oil burner heater.*

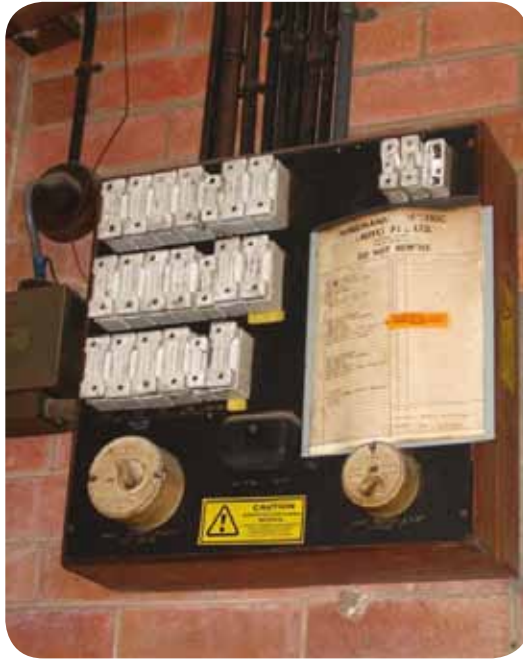
*Typical old-style switchboard with ceramic fuses.*

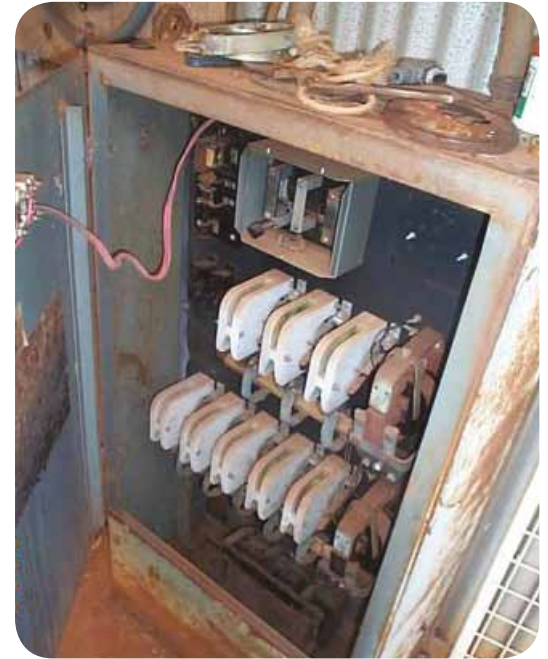
*Mechanical switchboard with ceramic fuses.*

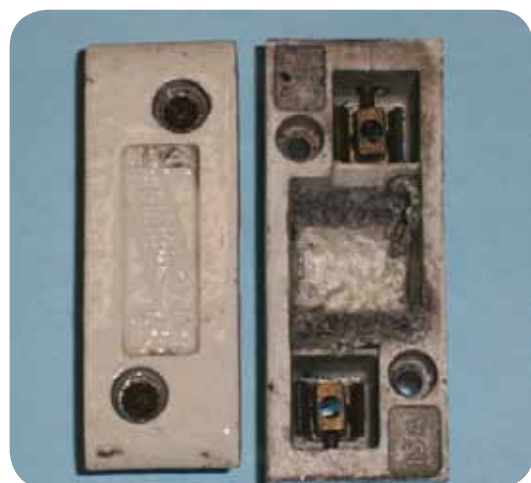
*Ceramic fuse holder with a textile spark/flare arrester.*
